**HOME
INSPECTIONS**

Report Number:
12-267

12345 Main St. Any Town, Washington 98000

Report Overview

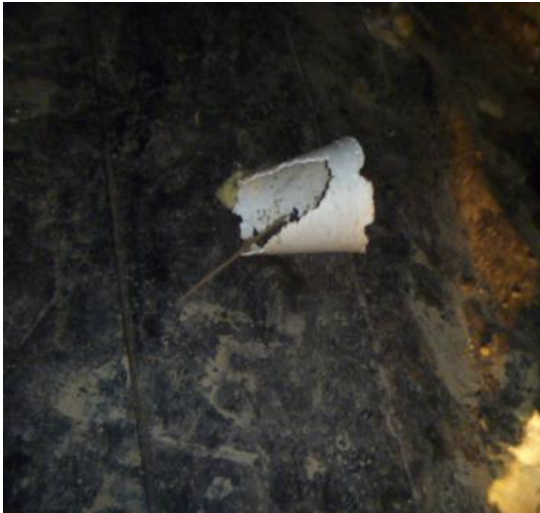
- There is evidence of vermin activity in the crawl space. A pest control specialist should be consulted for treatment and control advice.

Figure 1 Rodent activity

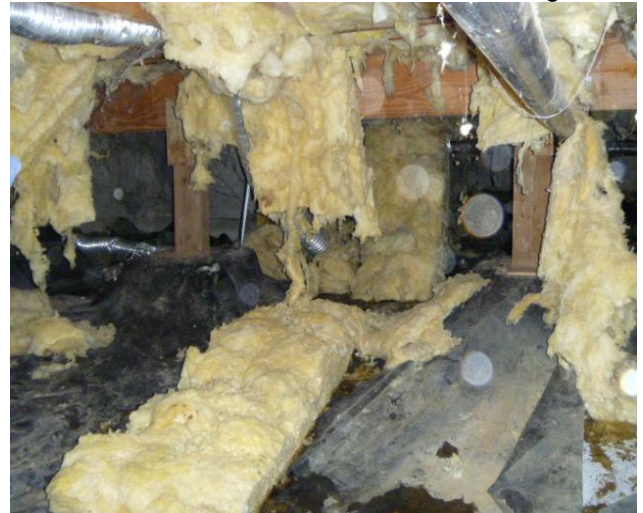
Figure 2 Rodent and pest activity

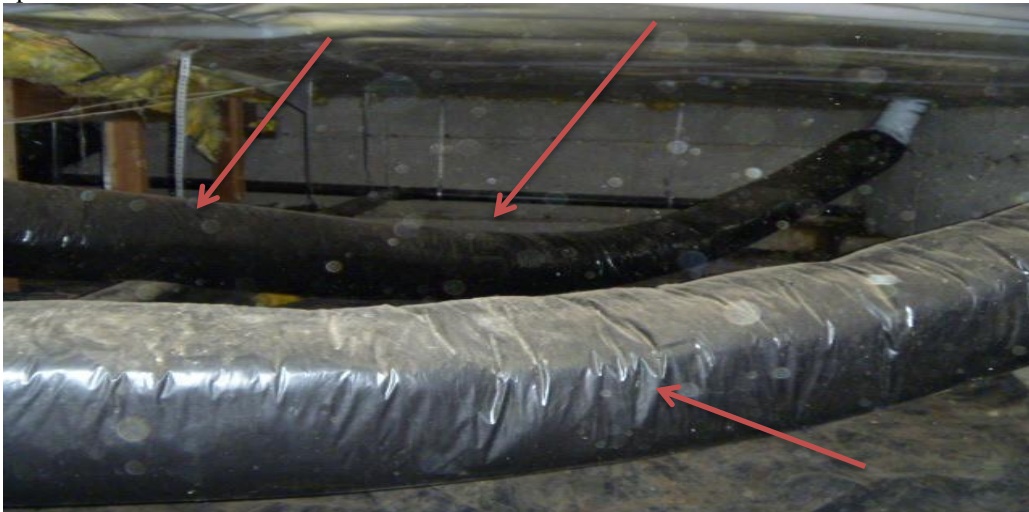
- Loose ductwork in the crawl space should be secured to avoid damage or improper and potentially unsafe system operation.

Figure 3 Unsecured ductwork

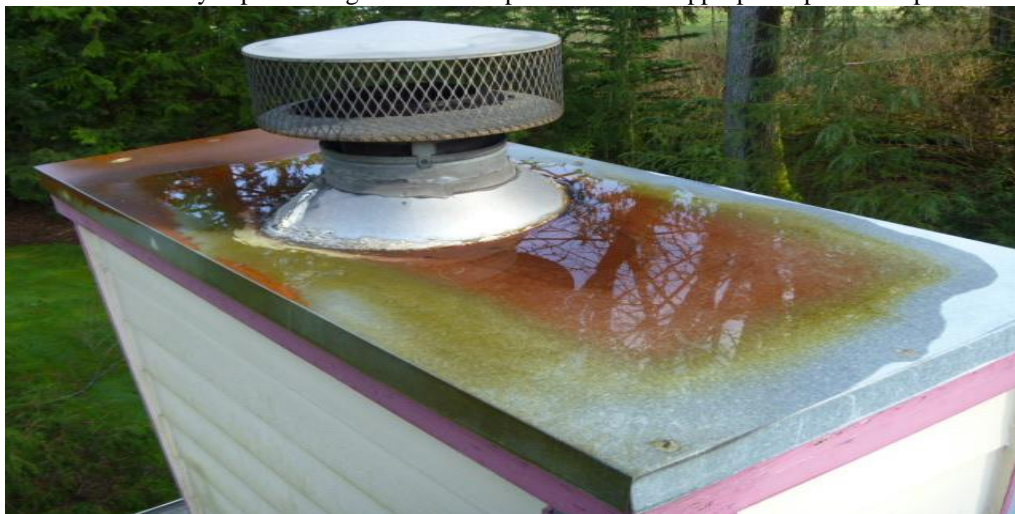
- The metal chimney cap is rusting. It should be painted with an appropriate paint or replaced.

Figure 4 Rust on chimney cap

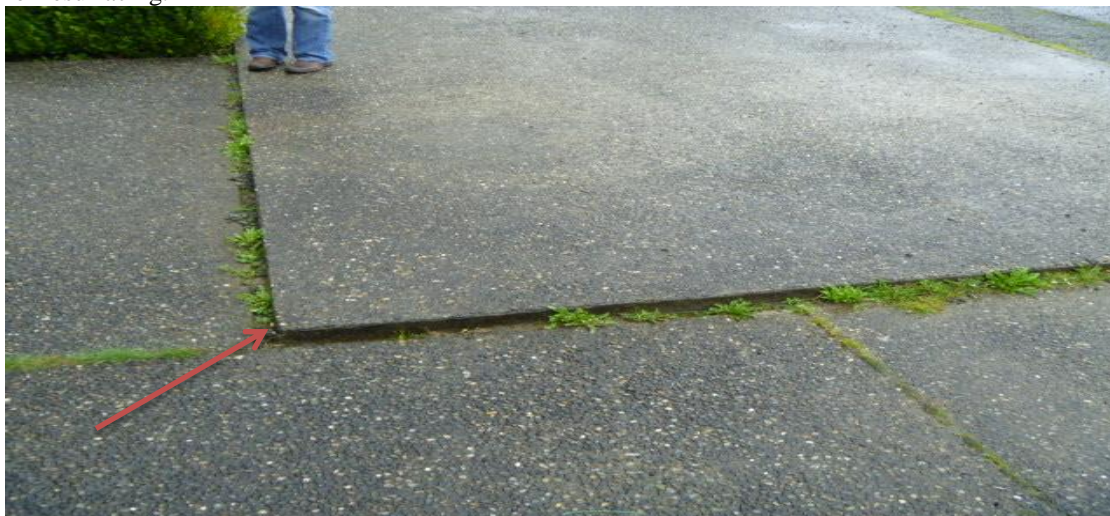
- The soil below the driveway has settled and/or heaved. Persisting movement may result in the need for resurfacing.

Figure 5 Resurfacing of driveway needed

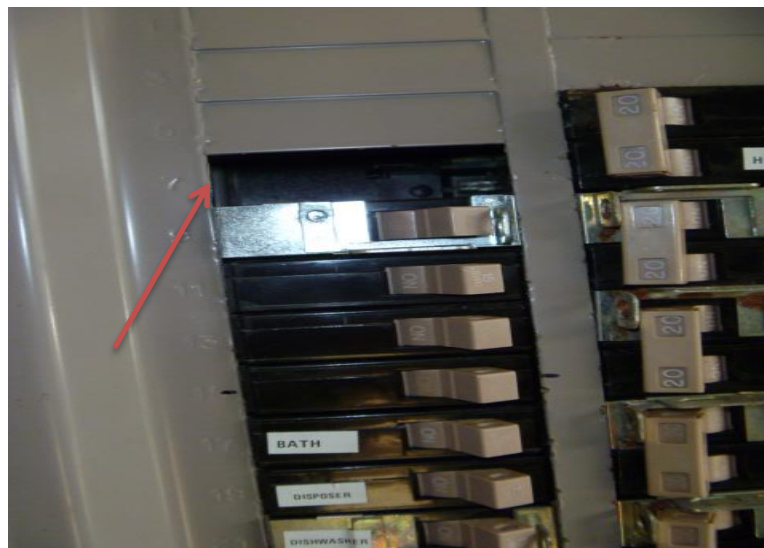
- The main electrical circuit panel had missing "knock-outs". The holes in the circuit panel cover allow access to "hot" conductors. Install blank covers for safety purposes

Figure 6 Missing "knock-out"

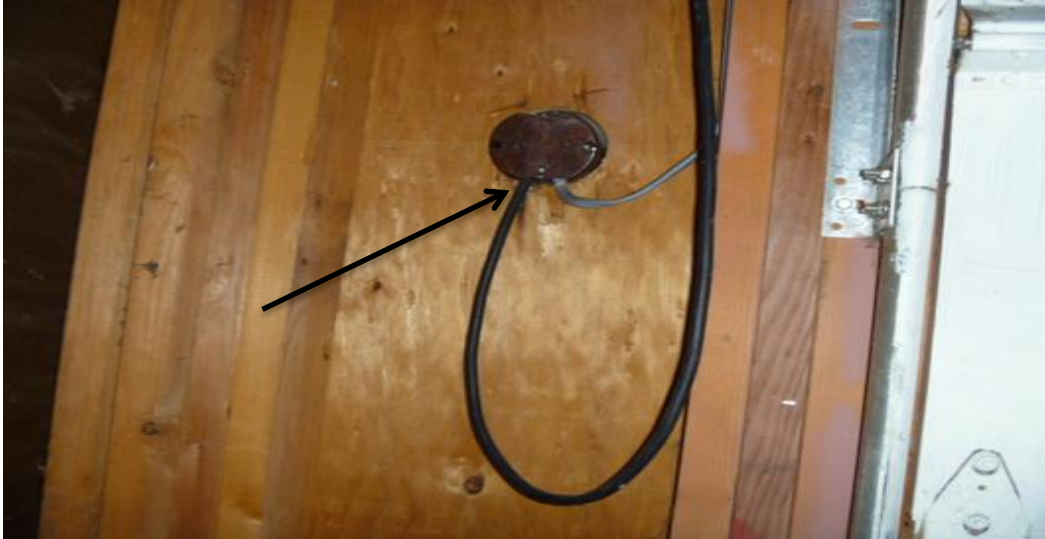
- The installation of the distribution wiring in the garage is non-standard. It is suspected that installation was performed by an amateur, rather than a licensed electrician.

Figure 7 Non-Standard wiring

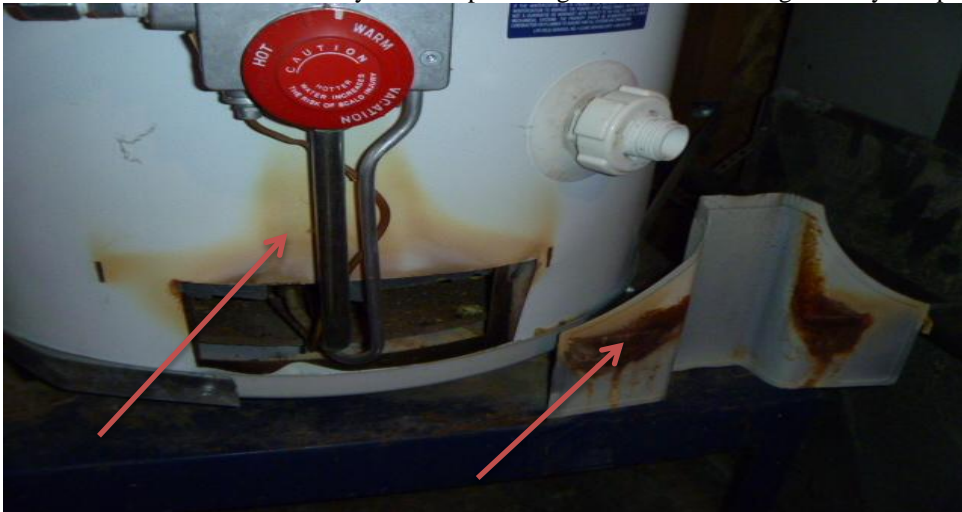
- There is evidence that the gas flame for the water heater is rolling out of the combustion chamber on startup. Recommend further evaluation by licensed plumbing contractor or local gas utility company.

Figure 8 Flame roll-out scorching

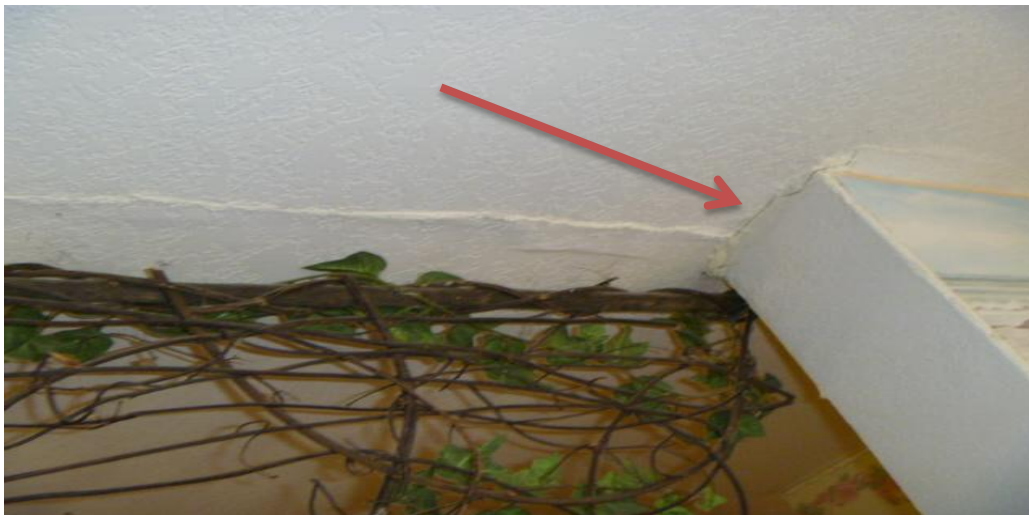
- Typical drywall flaws were observed in the kitchen due to “truss uplift”. Recommend repairs.

Figure 9 Truss uplift cracks
